# ILLINOIS AND MICHIGAN CANAL NATIONAL HERITAGE CORRIDOR

**Volume II: Morris**

HABS/HAER Division  
National Park Service  
U.S. Department of the Interior

### **VOLUME II: MORRIS**

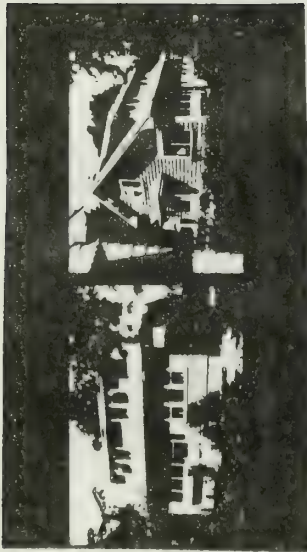
Roll 39

Example of bungalow house built in Morris in the late 1920s-early 1930s. Built on the rear of a lot formerly the site of the rear section of 409 W. Main St. Smaller, infill housing in west residential area.

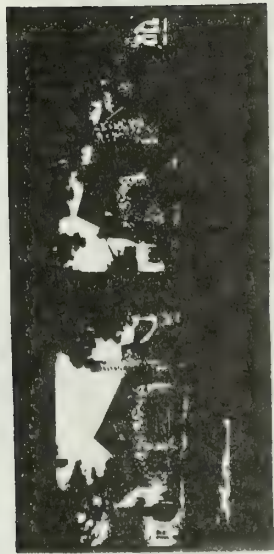
Roll 40

Example of late 1930s-early 1940s Tudor cottage. Built on prominent corner site in west residential area on site of 19th century brick residence that was removed ca.1920-25.

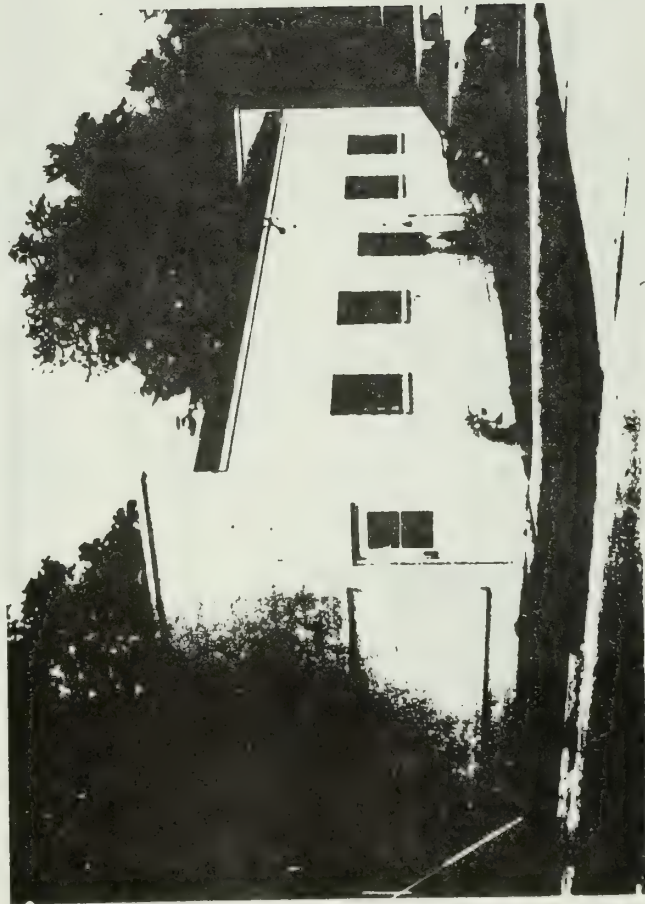
## Roll 30, 1

Initial use of site reflects the early importance of the canal to local industrial and agricultural development. Existing building is representative of the later commercial development that occurred along the I&M Canal in the early-mid 1900s. Additions and alterations have compromised the architectural integrity of the structure.

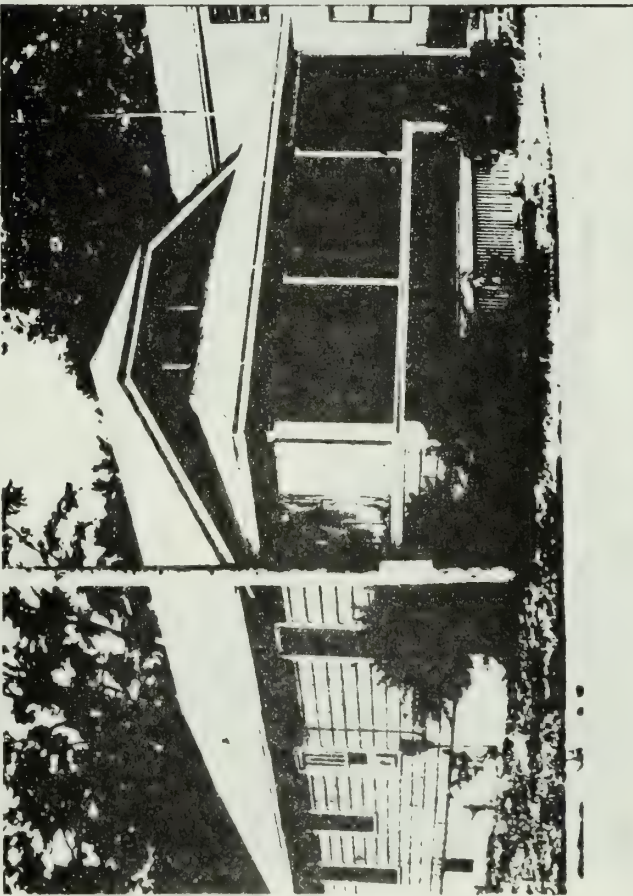
Roll 30, 4

The intial use of the site reflects the early importance of the canal to local industrial and agricultural development. Existing structure is representative of the many bungalows constructed in Morris in th 1920s.

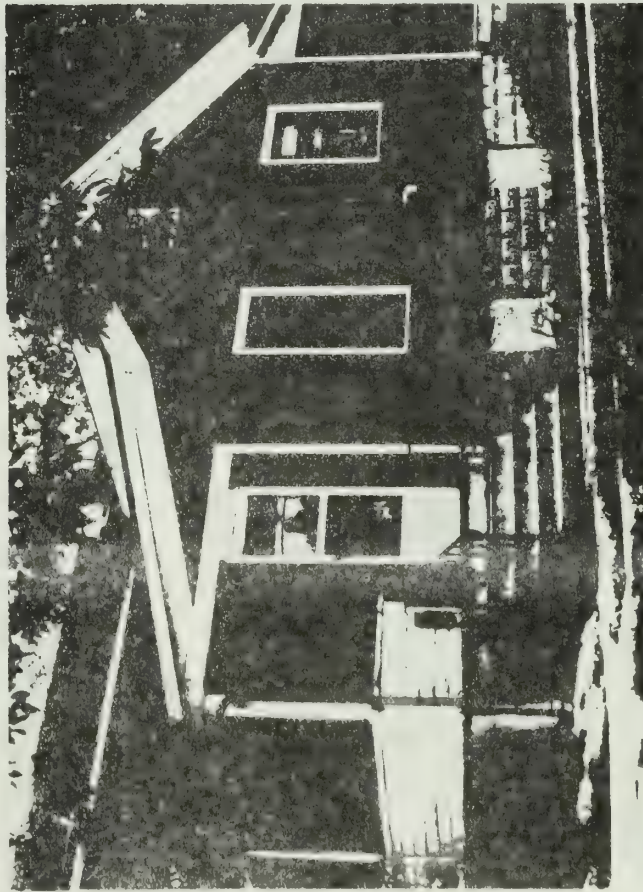
Roll 30, 2

The initial use of the site reflects the early importance of the canal to local industrial and agricultural development. Existing structure, with its Greek Revival influence dating to the mid-late 19th century, has been moved to this site.

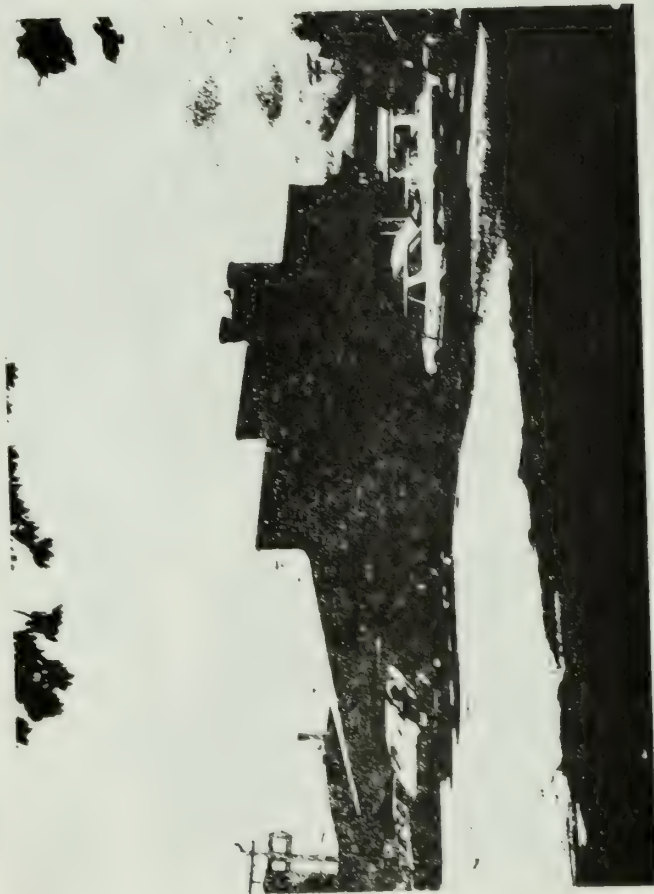
Roll 29, 28

Building is representative of the later commercial development that occurred along the I&M Canal in the 1920s and 1930s. Structure is compatible in scale and appearance with its surroundings. Architectural integrity of structure has been compromised somewhat by alterations.

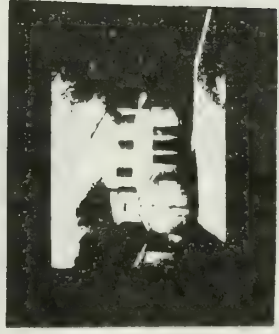
Roll 13

This early structure is perhaps the oldest surviving residential building located directly on the canal in Morris. The setting and materials of the building are intact and little altered. A valuable contributor to the historical character of the neighborhood and the community.

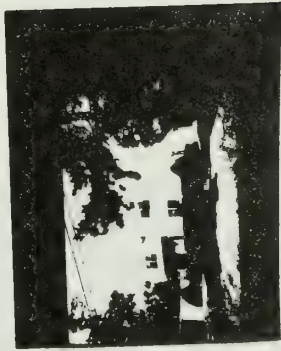
Roll 13

Simple vernacular structure. Alterations have compromised the historic architectural integrity of the structure. Scale and setback contribute to the character of the canal neighborhood.

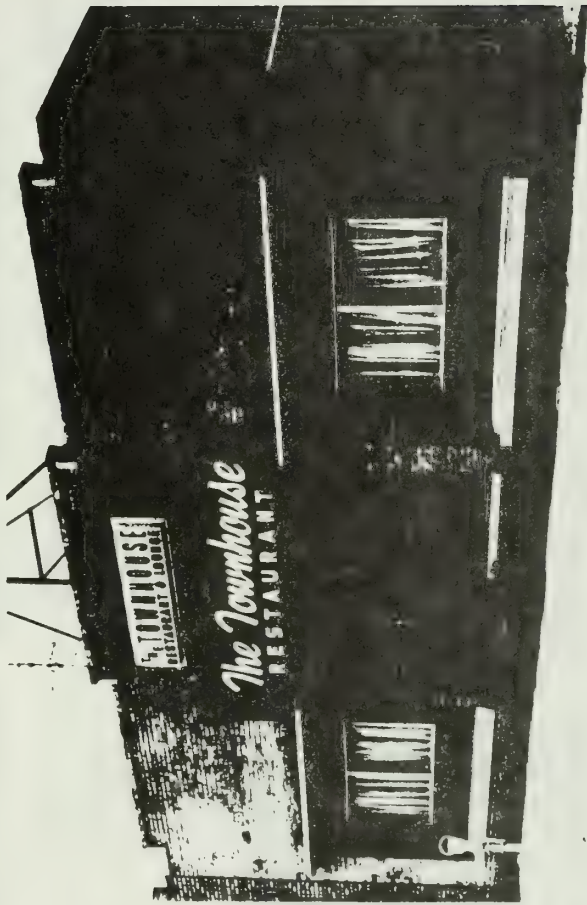
Roll 30, 25

Located on a secondary commercial street within the boundaries of the original town plat of Morris, the building is representative of the later commercial development in Morris in the 1930s-40s. The one-story brick structure is visually compatible with surrounding buildings.

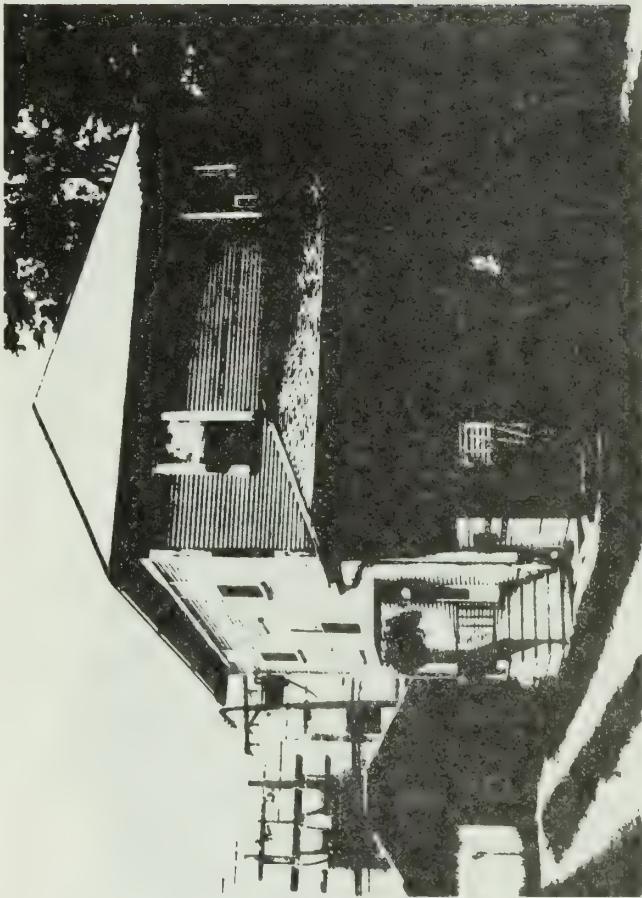
Roll 30, 30

Building is representative of the residential development in Morris at the turn of the century.

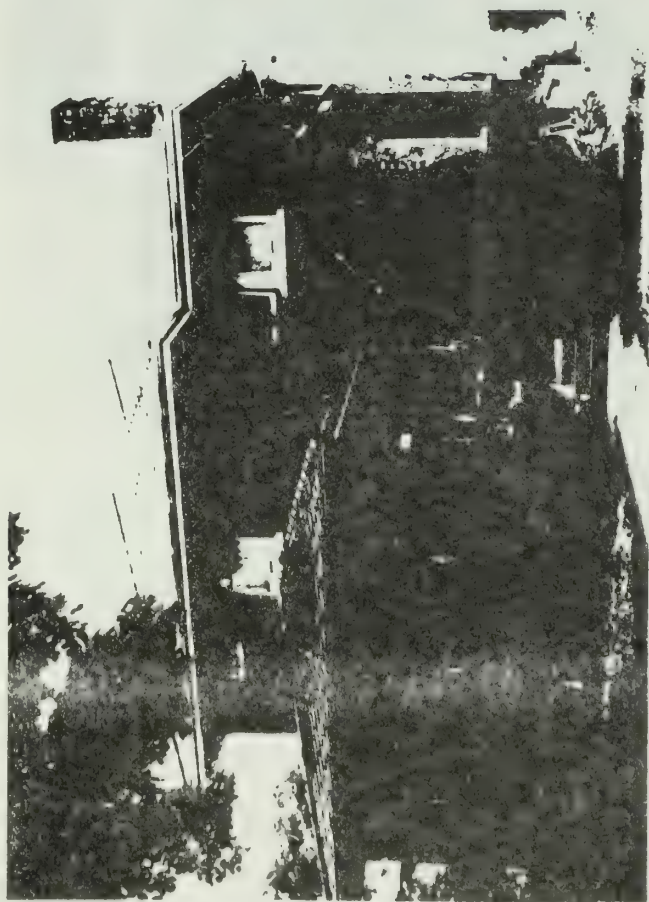
Roll 30, 31

Building illustrates the Prairie-style architecture which influenced many of the 1920s bungalows built in Morris.

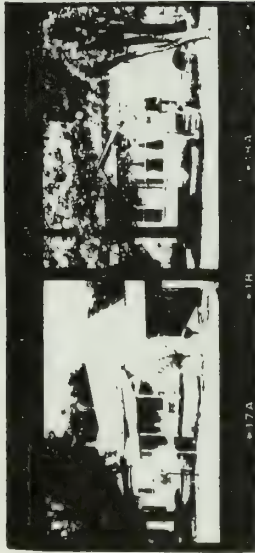
Roll 35

The small scale of this Plains cottage is typical of many of the modest dwellings constructed in Morris at the turn of the century. Recent alterations and additions have compromised the architectural integrity of the structure.

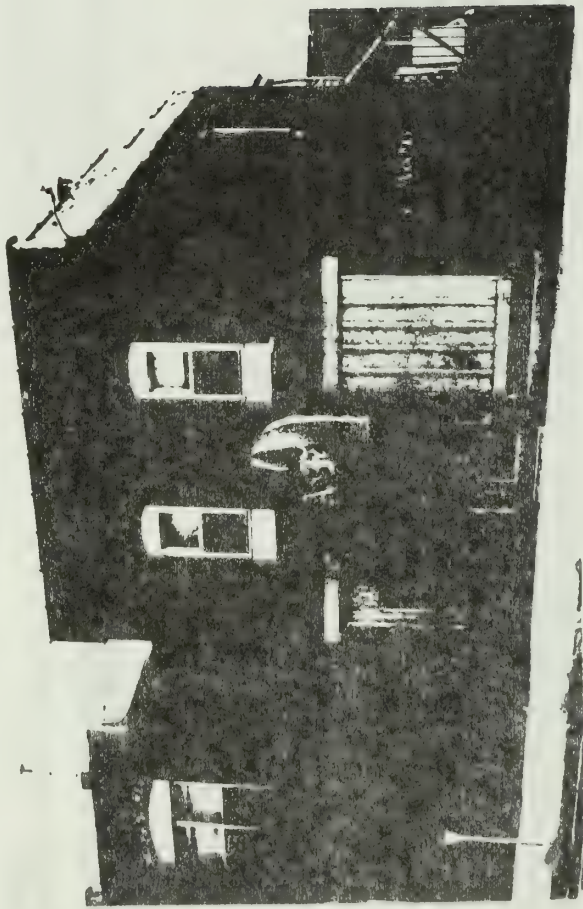
Roll 30, 14

Smaller in scale, yet reproducing many of the visual elements of the adjacent commercial block, this building illustrates the northward progression of commercial activity along Liberty Street and its secondary commercial avenues from the I&M Canal to the railroad in the 1800s. Subsequent alterations and additions have compromised the architectural integrity of the structure.

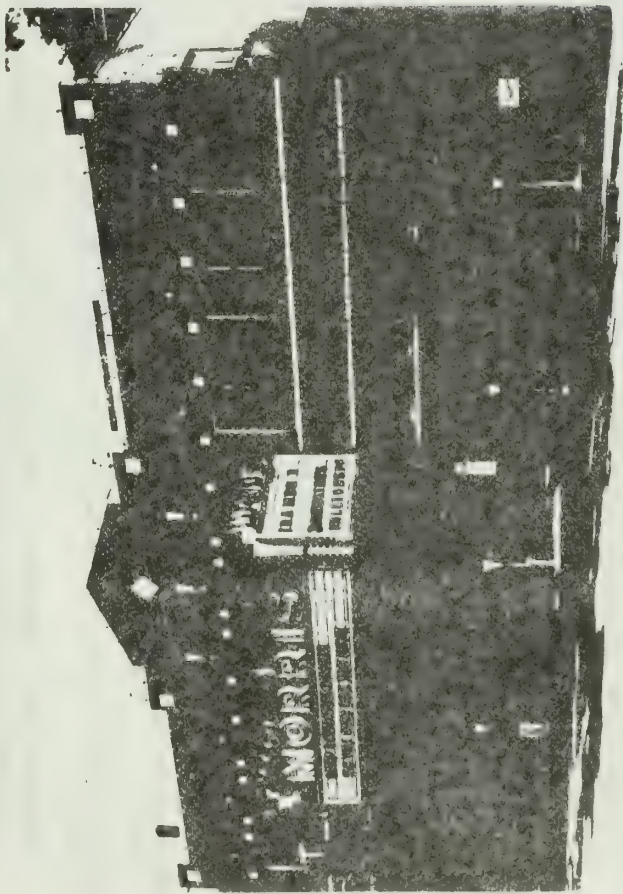
Roll 30, 12

Located on a secondary commercial street, the theater is a good example of the general scale and appearance of the commercial development in Morris in the 1920s-1930s. Scale of building is similar to that of surrounding structures.

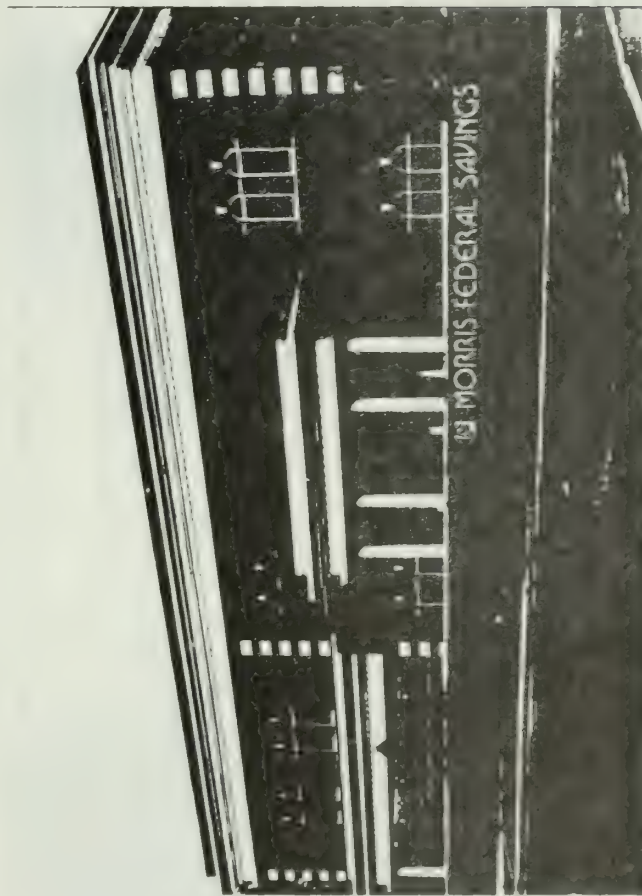
Roll 30, 32

Located within the boundaries of the original town plat of Morris, the building is a non-contributing structure, visually incompatible in both scale and appearance with the surrounding historical commercial development.

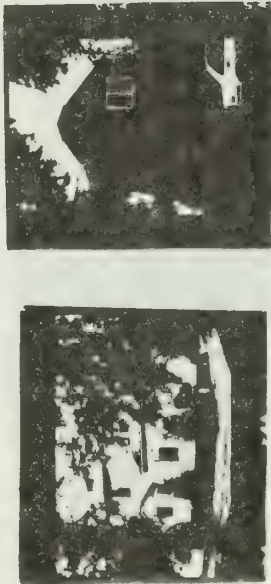
Roll 35

A variety of alterations and additions have compromised the architectural integrity of this early twentieth century residence.

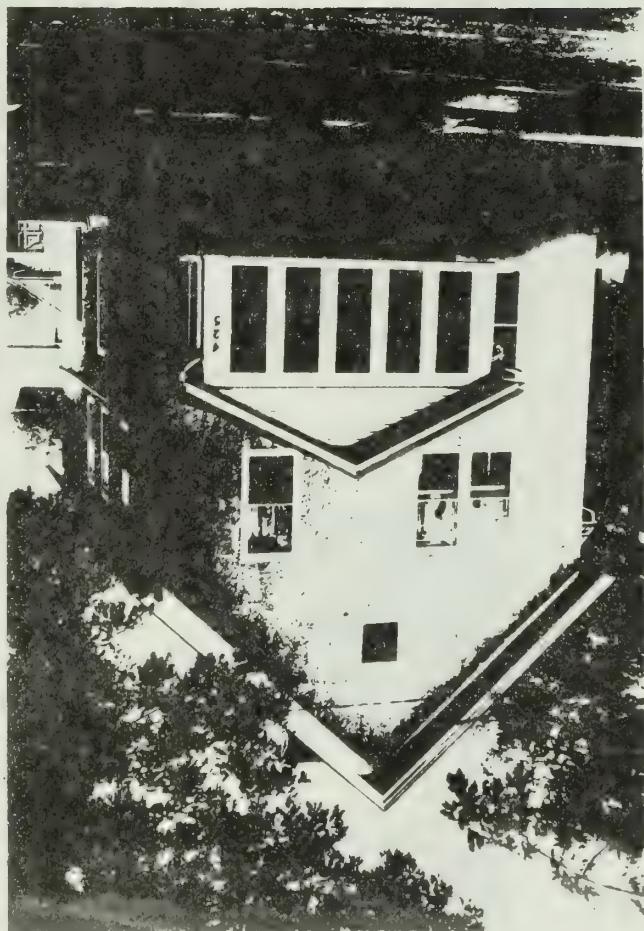
Roll 34, #36

The scale and appearance of this simple, front-gabled dwelling is typical of the residential construction occurring throughout Morris in the mid-to-late 1800s. Subsequent alterations and additions have compromised the architectural integrity of the structure. The building was the home of John Costello, an English farmer residing in the area in the 1850s.

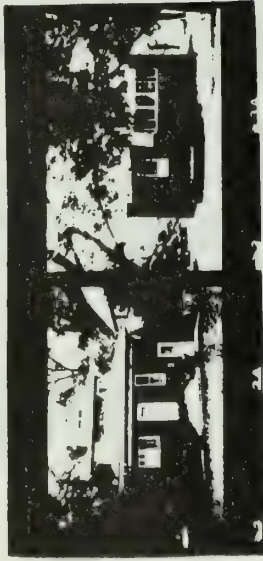
Roll 35

Dwelling is representative of the two-story, rectilinear hipped-roof bungalow houses scattered throughout Morris. The Prairie-style architectural influence evident here, may be found in many of the residential structures constructed in the community between 1905 and 1930. The second-story balcony treatment is a unique feature of this building.

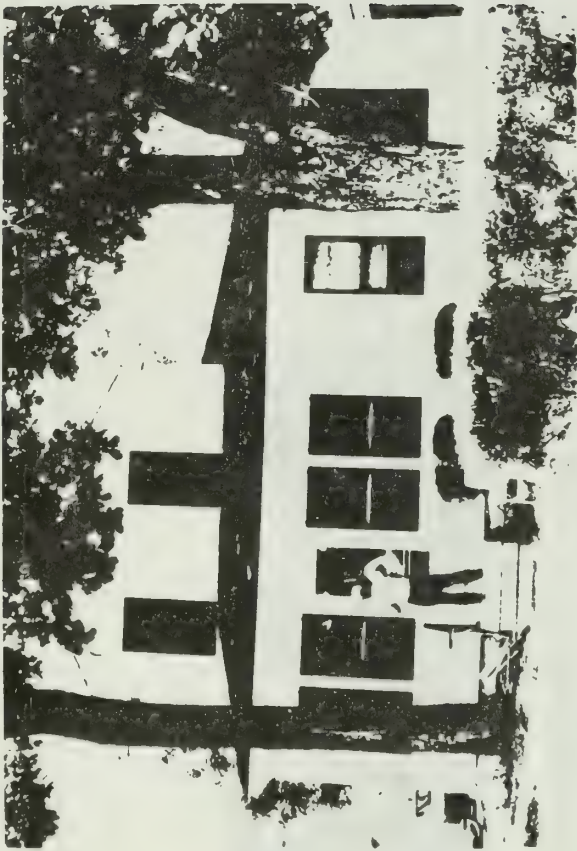
Roll 31, 33

Located within the original platted area of Morris, adjacent to the commercial district, the building is representative of the early residential structures of the community.

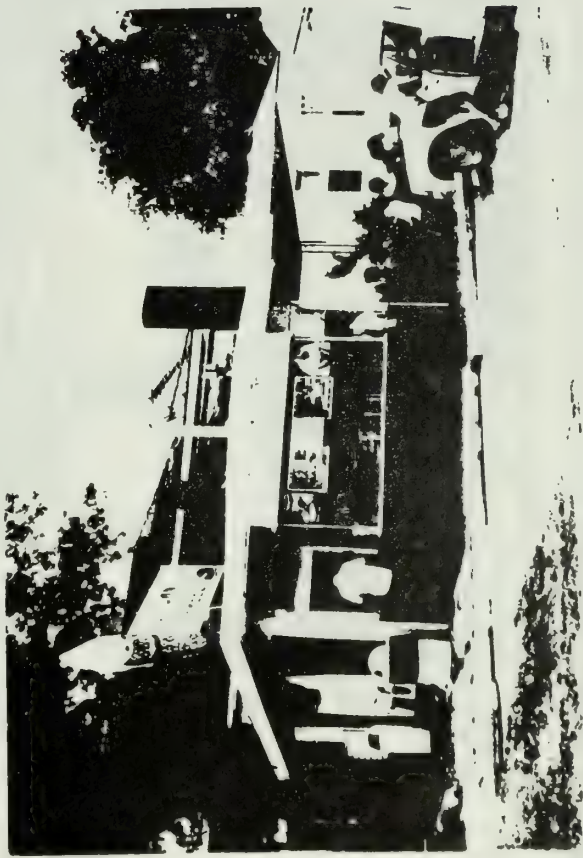
## Roll 31, 32

Smaller in scale than much of the early commercial development in Morris, the building is, however, on a secondary commercial street.

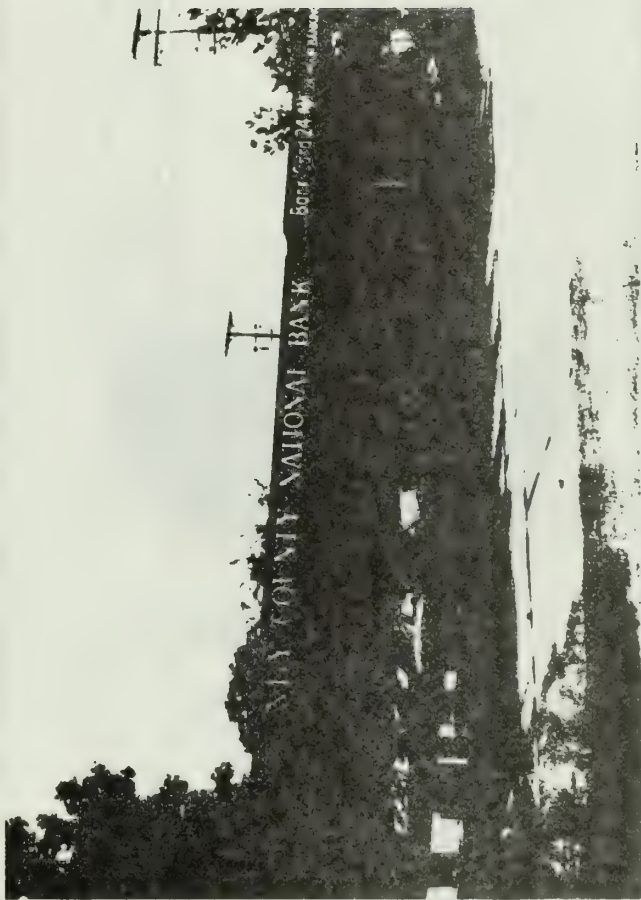
Roll 30, 37

Located within the limits of the original town plat of Morris, the drive-up banking facility is a non-contributing visual element in the downtown commercial core.

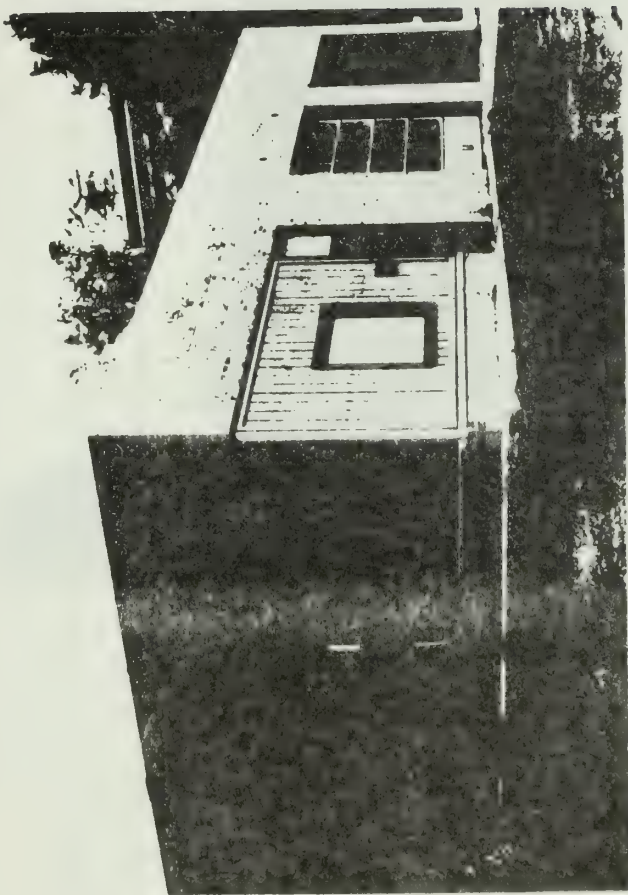
Roll 30, 35

Building is representative of the scale of much of the early commercial development in Morris in the 1800s. Subsequent alterations and additions have compromised the architectural integrity of the structure.

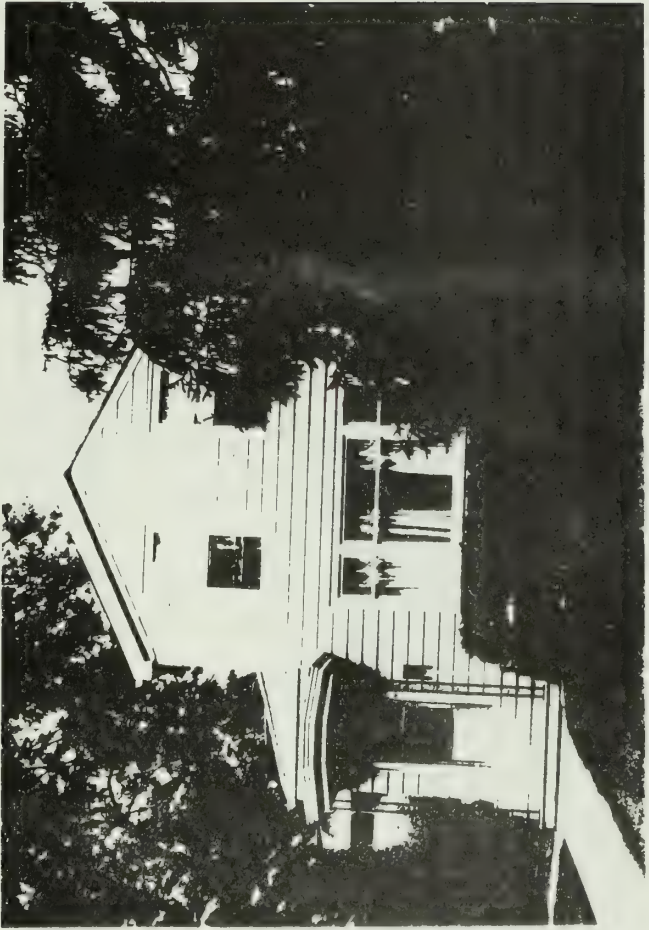
Roll 34, #20

The scale and appearance of this early gabled-ell dwelling is typical of the residential construction occurring in Morris in the late 1800s. Subsequent alterations have compromised the architectural integrity of the structure.

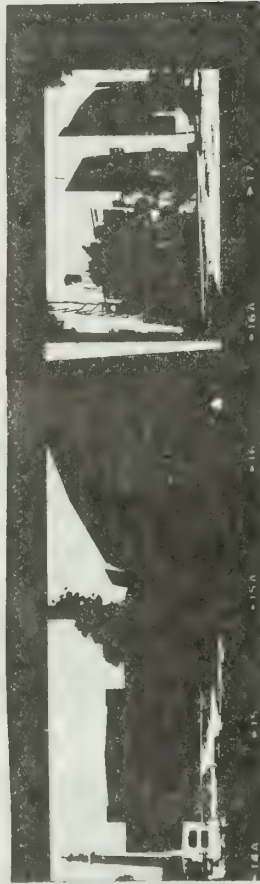
Roll 27

Site of first (1842) and second (1856) Grundy County courthouses. Outside walls of second courthouse were retained and used as inner walls of 1912 structure. Important in the political history of Grundy County. Local architectural significance as example of early twentieth-century neoclassical style with later cornice modifications in a restrained art deco style.

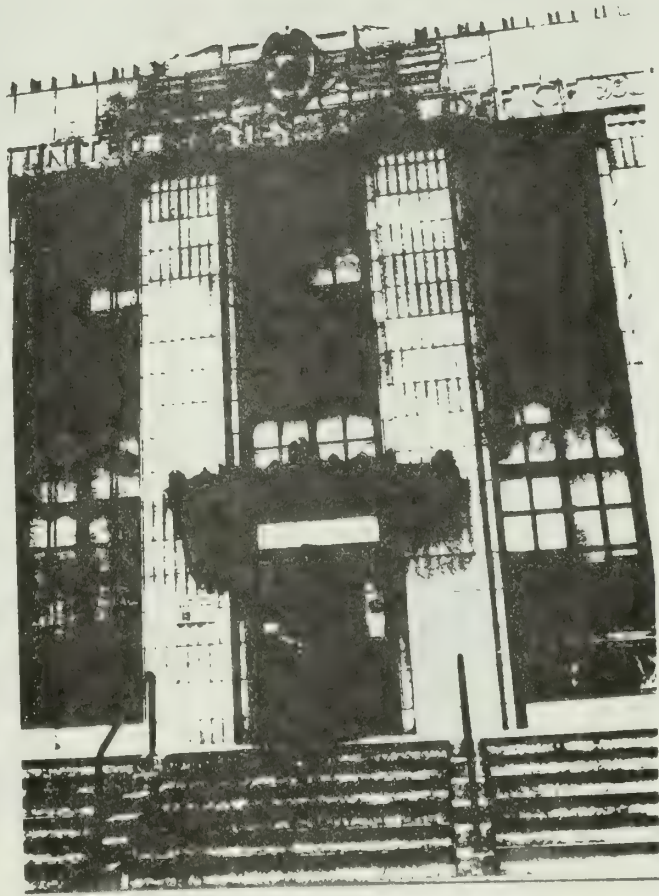
Roll 29, #32

This Art Deco post office is typical of many public buildups constructed during the 1930's under the large public buildings program initiated under the Department of the Treasury. While similar to the other post office from this period in cities and towns throughout the country it is an important public building in Morris and the major example of this type of architecture.

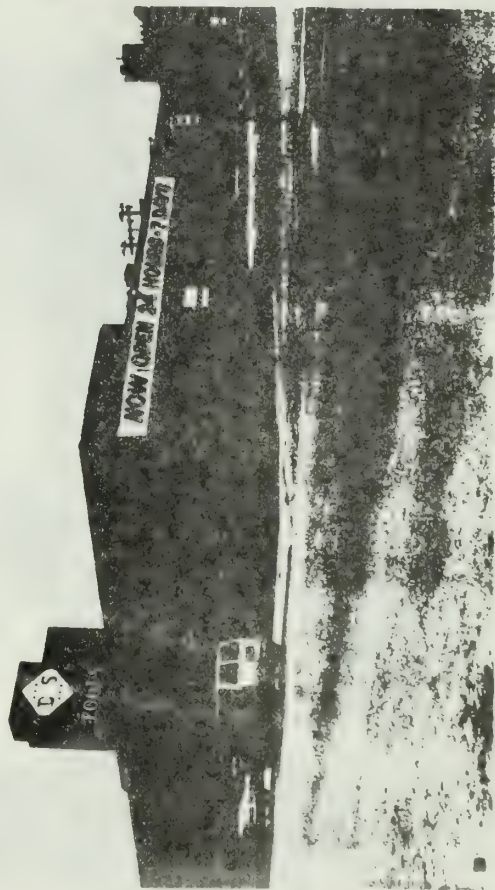
Roll 29, 33

Modern intrusion into original town plat of Morris. Existing structure is visually incompatible with much of the commercial development in the central business district.

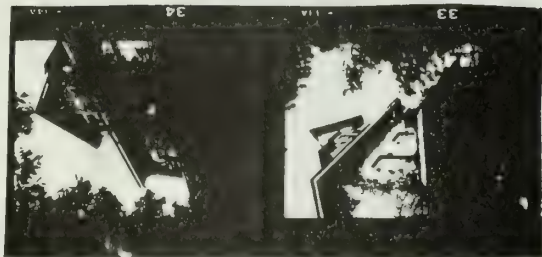
## Roll 33

The Prairie-style architectural influence evident here, may be found in many of Morris' later residential structures (ca.1900-1925). However, the secondary mission, Eastlake and Italianate details along the cornice and in the various window treatments is unusual. A structure similar in scale and appearance is located across the street. The architectural integrity of the building has remained virtually intact.

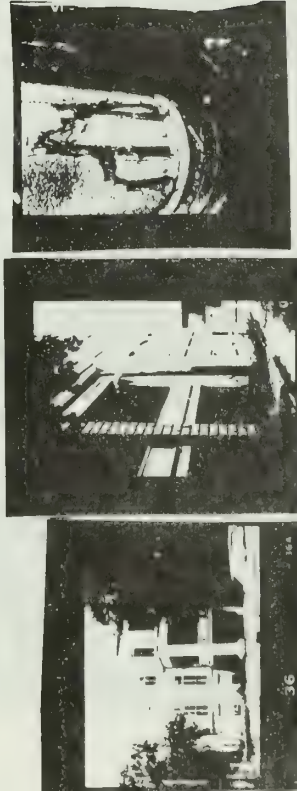
Roll 33

This early three-story residence is of a larger scale than much of the residential development occurring in Morris' east side. The Adam/Federal architectural influence evident here is uncommon.

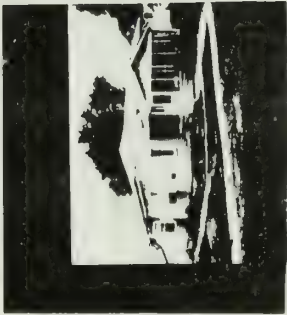
Roll 36

This simple vernacular structure is typical of the modest houses built along the canal. Alterations and additions have compromised the architectural integrity of the structure.

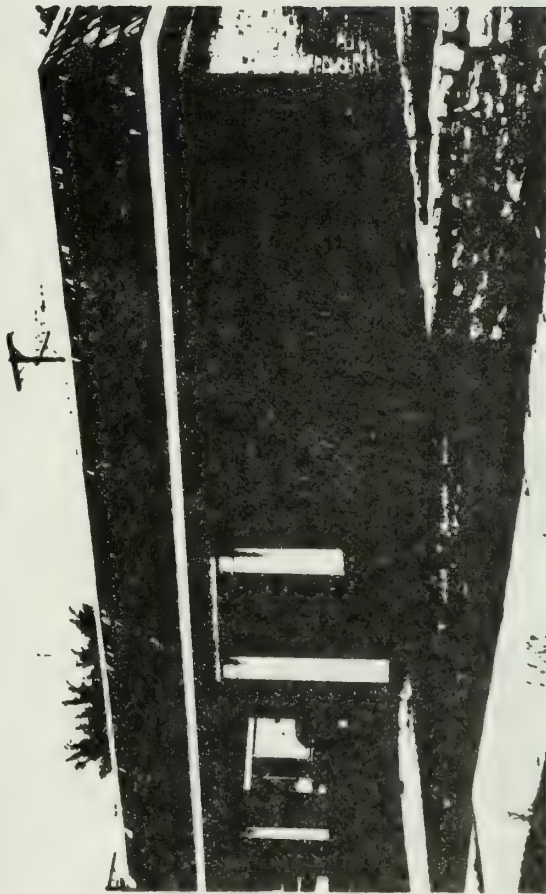
Roll 30, 36

Brick cladding, running bond. Rectangular plan with three-bay front. One story. Mansard-like roof with wood shake shingles. Drive-up service entrance on west facade. Main facade faces south.

Located within the boundaries of the original town plat of Morris, the existing structure is a non-contributing commercial element.

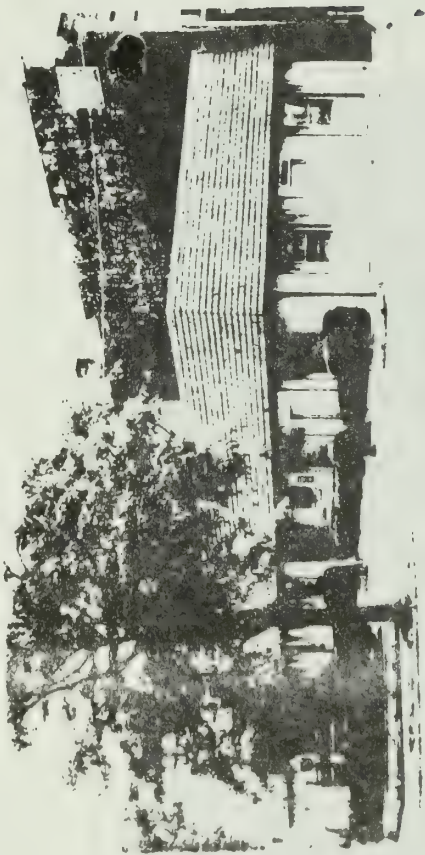
Roll 31, 30

Located on a secondary commercial street in the original platted area of Morris, the building is smaller in scale than surrounding commercial structures. Modern treatment detracts from visual integrity of the area.

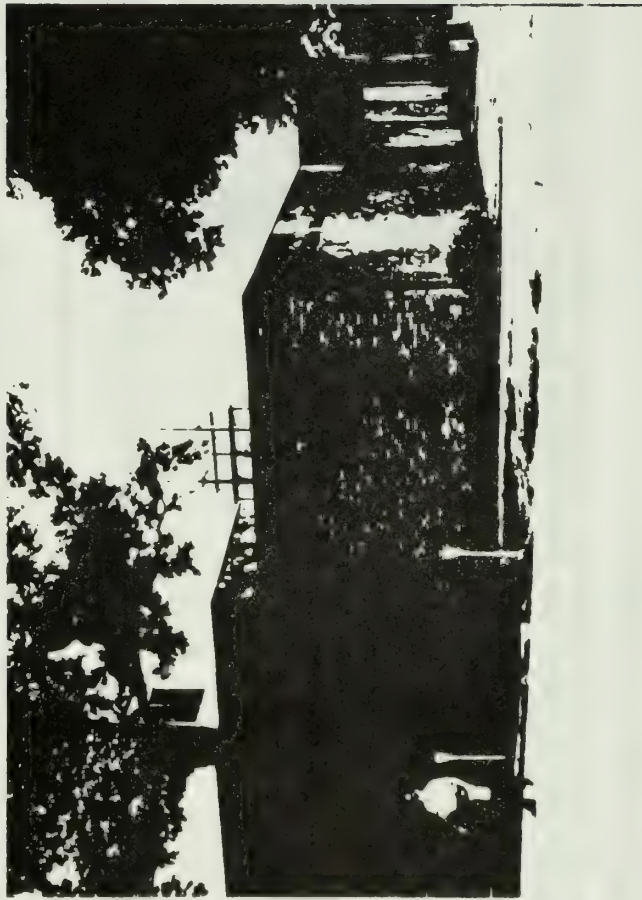
Roll 30, 11

Poured concrete foundation; decorative brick walls. Squared plan. One story. Flat roof. Narrow fixed windows, fluted panels above and below window openings. Main facade faces east; corner lot.

Located within the boundaries of the original town plat of Morris, this recently constructed building, while of a similar scale, is visually incompatible with the adjacent commercial and residential structures.

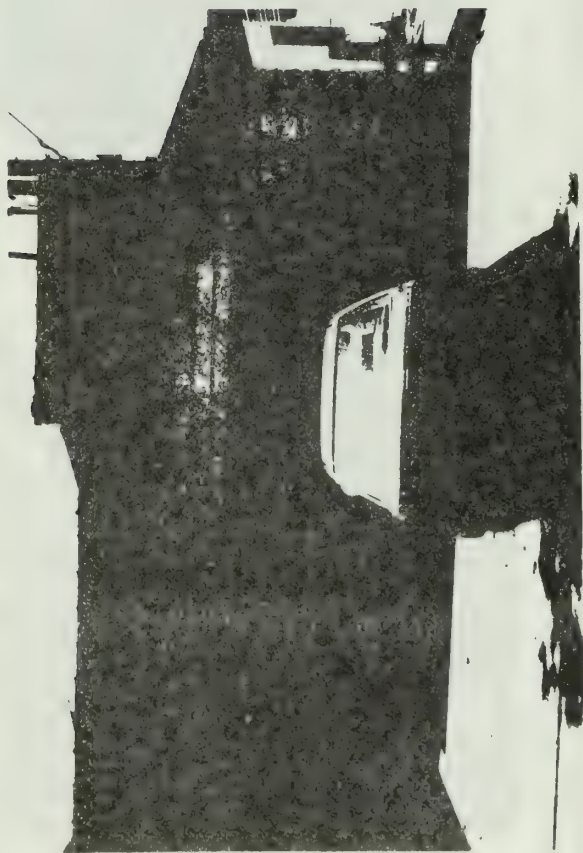
Roll 31, 29

Located within the boundaries of the original town plat of Morris, the structure is a non-contributing element in this commercial/residential neighborhood.

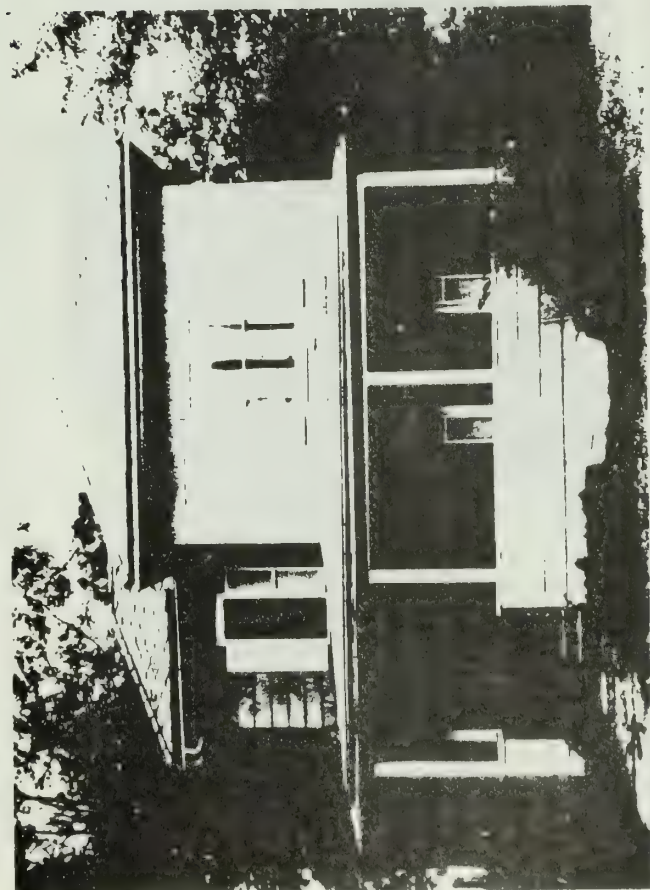
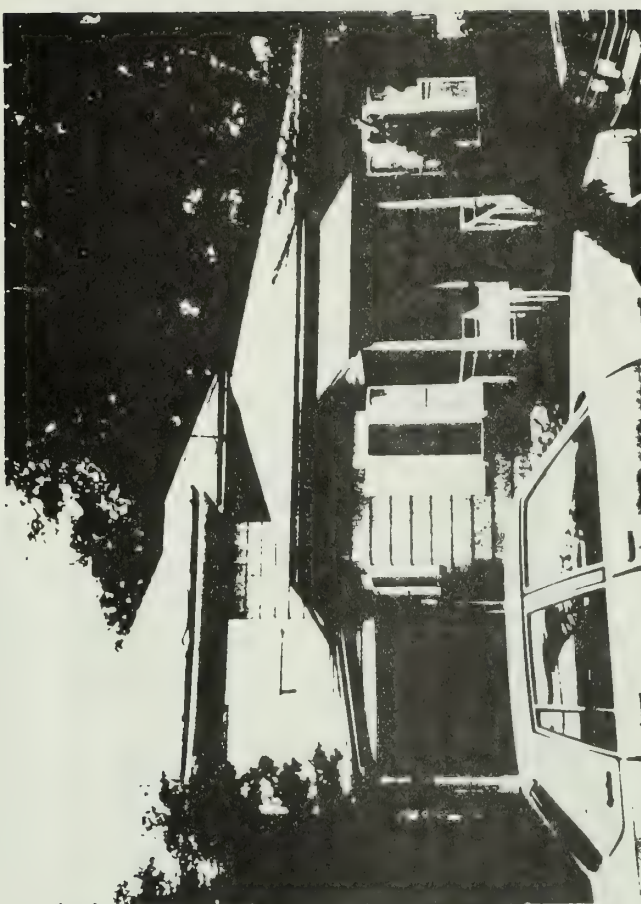
Roll 30, 28

Building is representative of the residential construction in Morris at the turn of the century. Subsequent alterations and additions have compromised the architectural integrity of the structure.

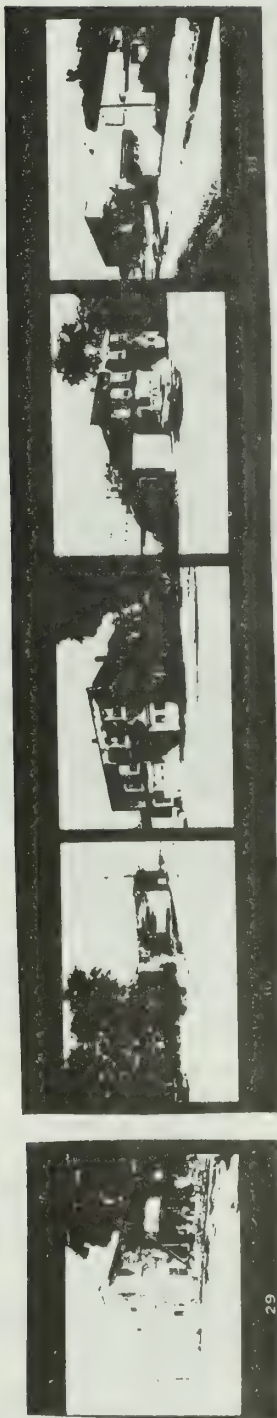
Roll 38

Important site along the canal. Formerly site of services related to the canal, blacksmith and feedyard. Integrity of architecture has been severely reduced by alterations, although building is compatible in scale and materials with surrounding structures.

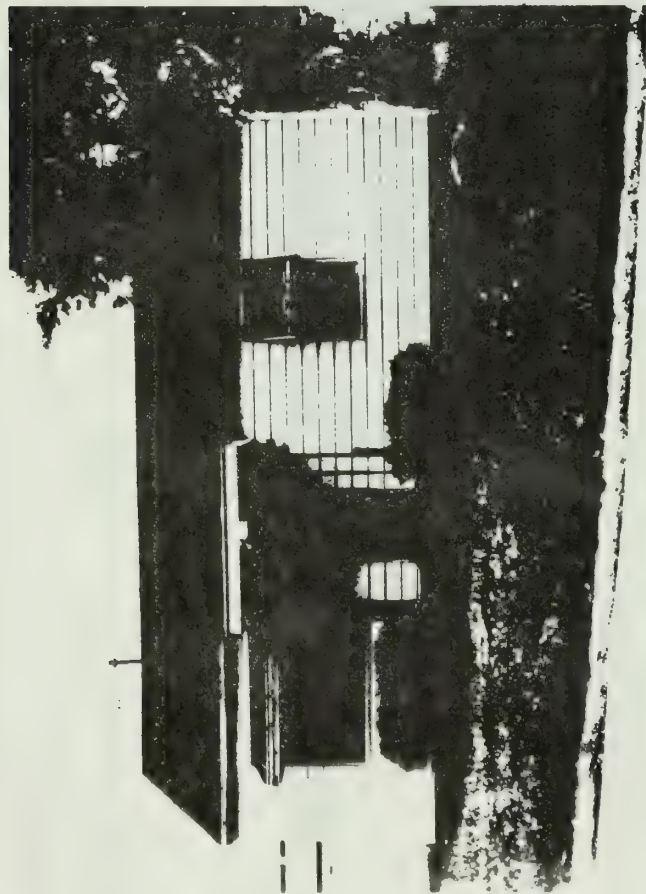
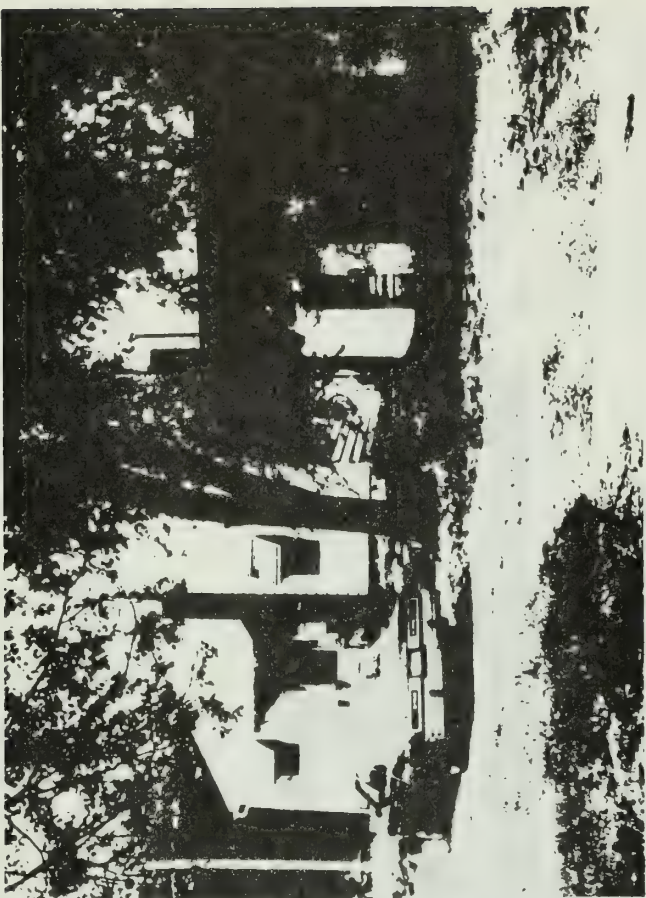
Roll 28, 31

Site is important for its proximity to the canal. Although garage may have been part of a 19th century structure, it appears to have lost all integrity.

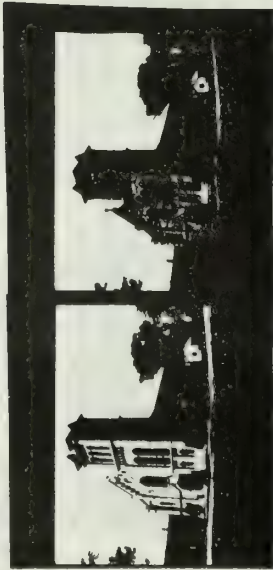
Roll 41

One of most significant structures architecturally in Morris. Built of local dolomite limestone, it is a fine example of the monochromatic Romanesque Revival style. In spite of alterations, retains a high degree of integrity, especially in the stonework. Currently for sale and faced with demolition if a buyer is not found. Worthy of consideration for HABS documentation.

Of the buildings surveyed this summer, consideration should be given to documenting the Romanesque Revival Congregational Church (Masonic Lodge), built in 1867, located at Fulton St. and W. Jefferson. The structure is currently for sale and faces demolition if a buyer is not found. This building is important historically in the early religious life of Morris. Architecturally, it is the most significant local building constructed of the local dolomite limestone. Visually, it occupies a prominent corner site on W. Jefferson, the major route connecting the western residential area with the downtown. Although it has lost its spire, has a later rear brick addition, and no longer has its original doors, the quality of the stone work and the Romanesque Revival detail that survive are worthy of documentation.

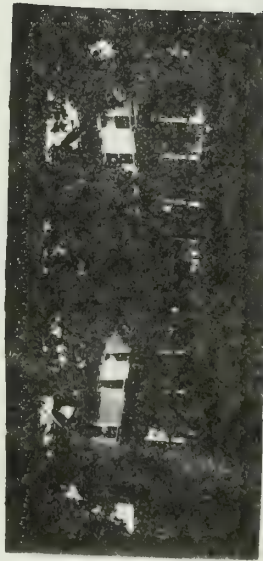
Roll 42

This Italianate residence still maintains the original details applied at the time of construction. Most buildings of similar age in Morris have had these decorative elements removed. The Italianate style was popular in the area, but this is a rare surviving example in good condition with a high degree of integrity.

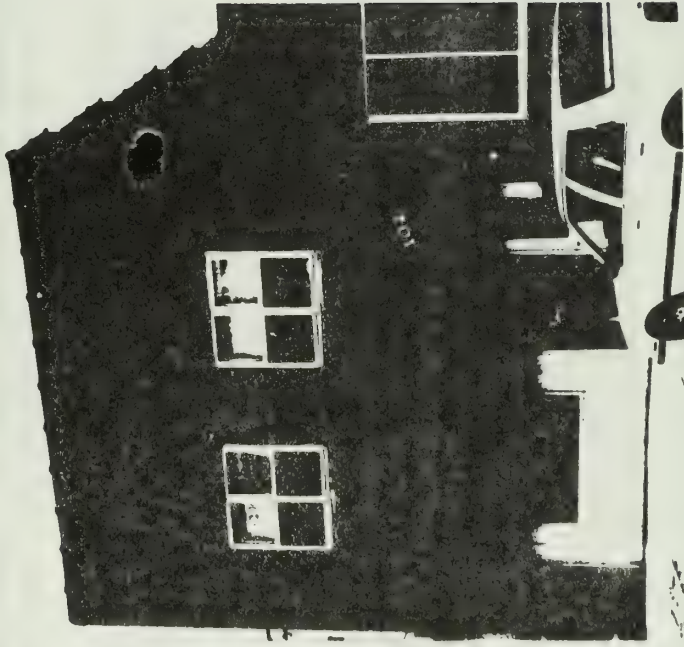
Roll 28, 22

Located near the I&M Canal, the building serves to reinforce the historical importance of the canal and clarify its relationship with the early industrial and commercial community of Morris. The building is typical of the smaller-scale industrial and commercial development that occurred along the canal in the 1970s and 1980s.

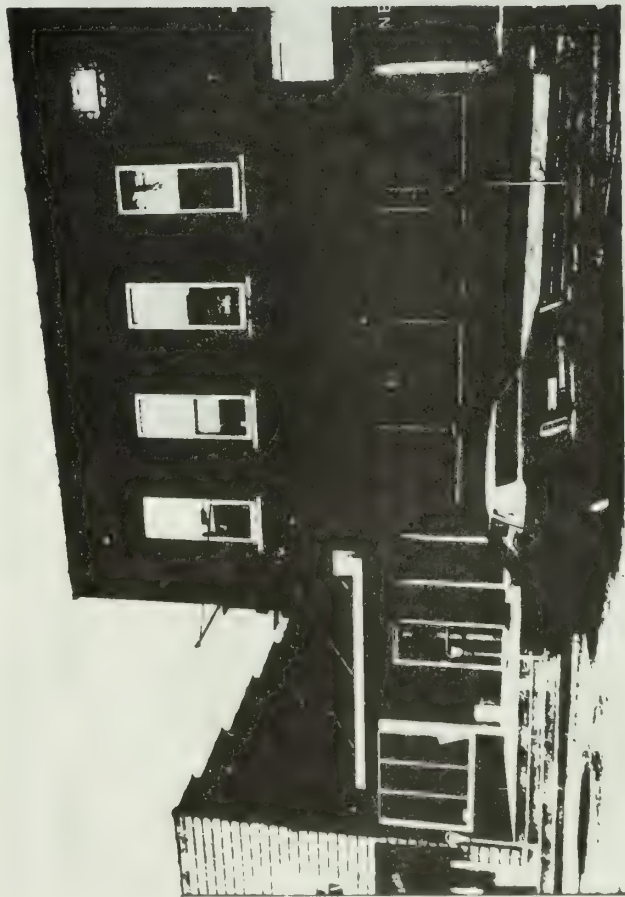
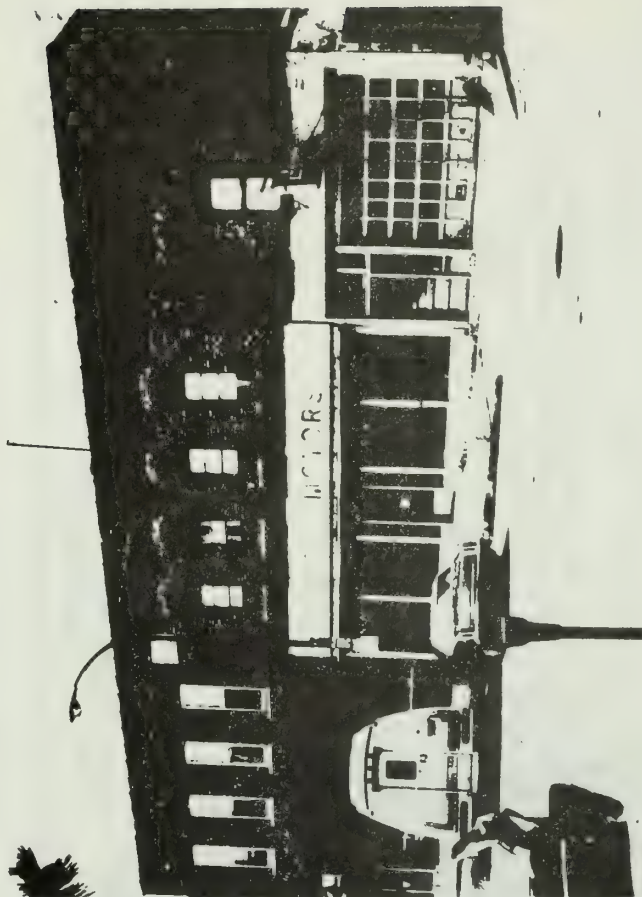
Roll 37,22

Important commercial location across from courthouse, one block from canal. Alterations have compromised architectural integrity of structure.

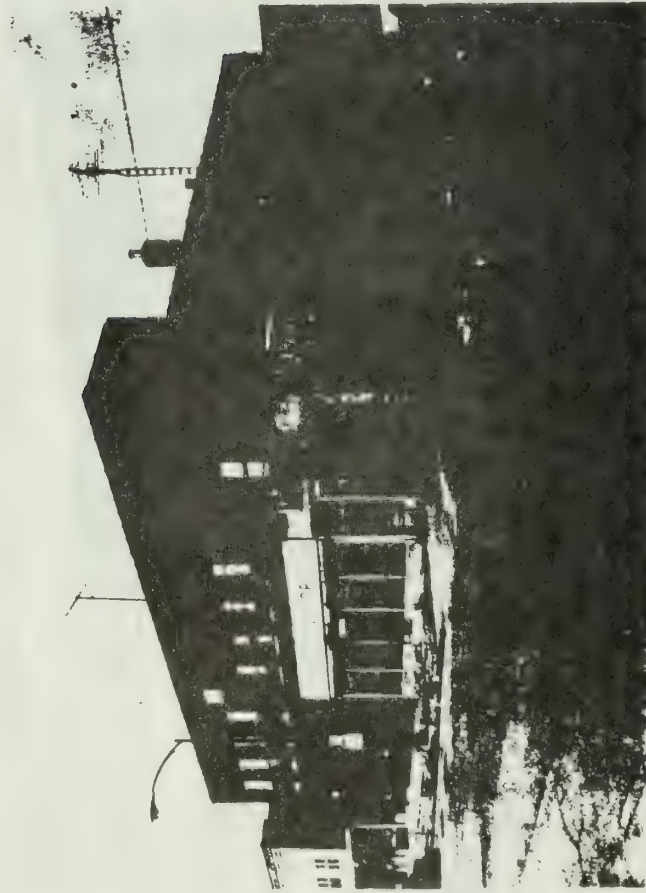
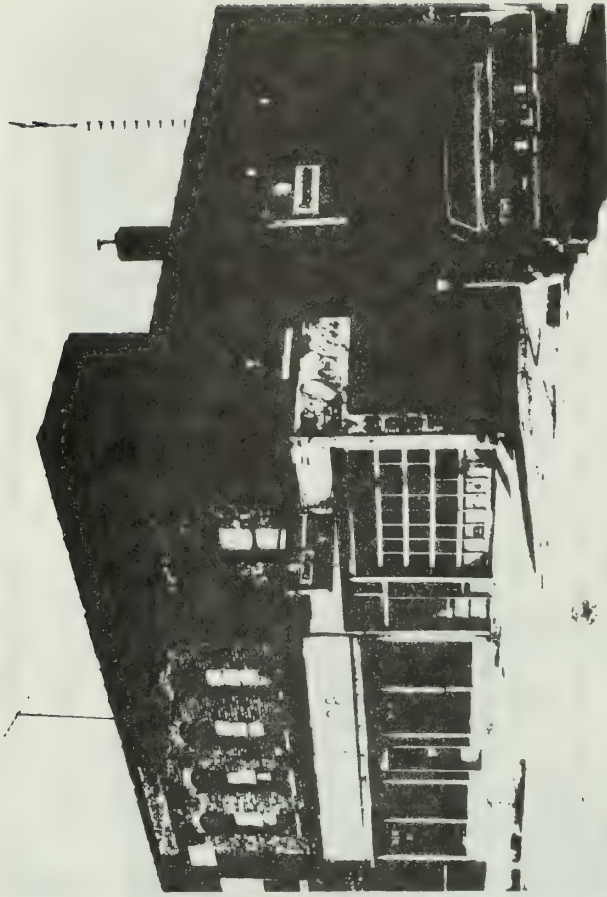
Roll 27, 24

Prominent commercial location across from courthouse, one block from canal. Important in mid-late 19th century development of Morris as the commercial center for Grundy County. Alterations have compromised the architectural integrity of the structure.
